Preliminary Information

PIT5445B Diagnostic Tip - Service Driver Assist Message

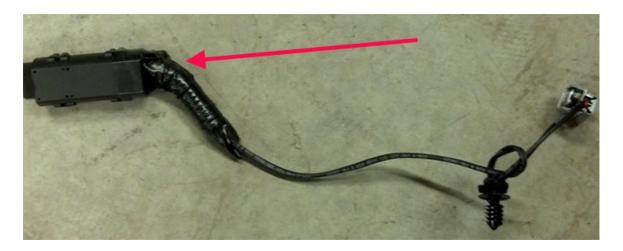
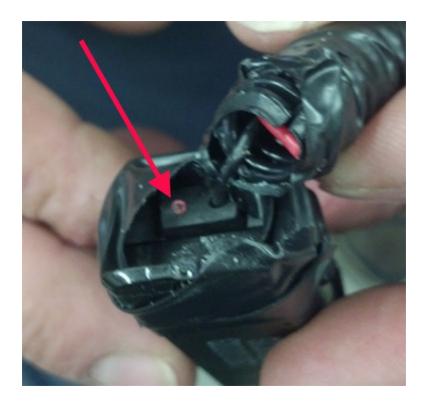
This concern could be caused by a Driver's Cushion Haptic Seat Motor circuit opened/high resistance near the motor, see pictures below

Tip: The haptic seat motor has a pigtail lead coming off the motor. In many cases, the wiring pigtail near the haptic seat motor has broken. Do not repair the pigtail wiring, replace the haptic seat motor.

Using the scan tool, go into the Seat Memory Control Module and command on the left and right driver's cushion haptic seat motors. If a haptic seat motor does not operate, follow SI and perform further diagnosis.
